CHATTAHOOCHEE RUN  
UPDATED CAPITAL RESERVE ANALYSIS FOR 2009

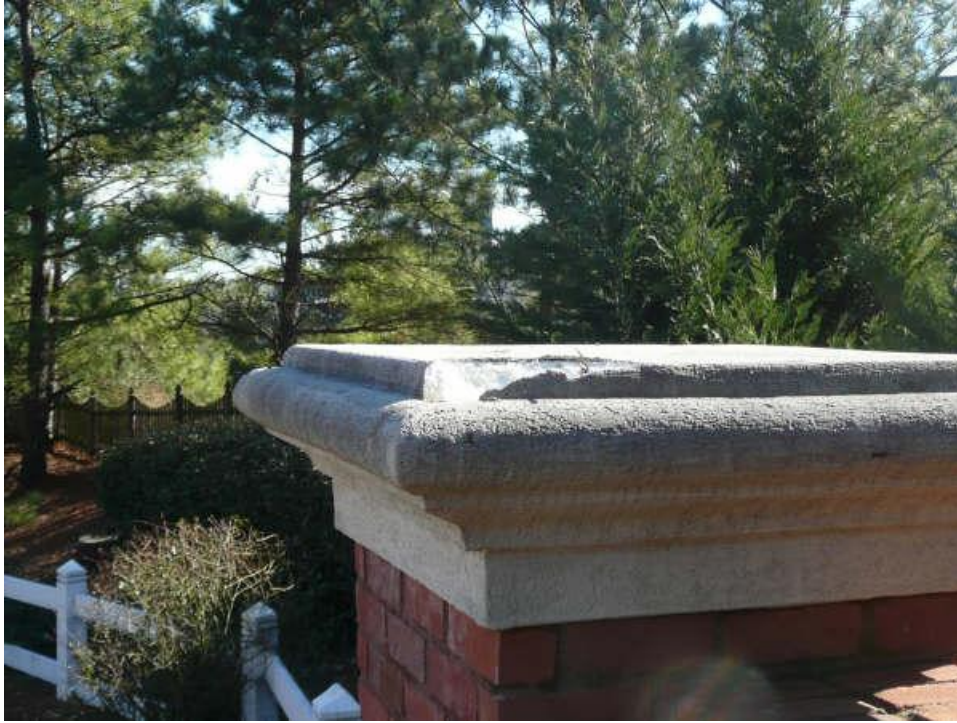
1. View of a synthetic stucco pilaster cap, showing typical damage along the top edge of the cap.

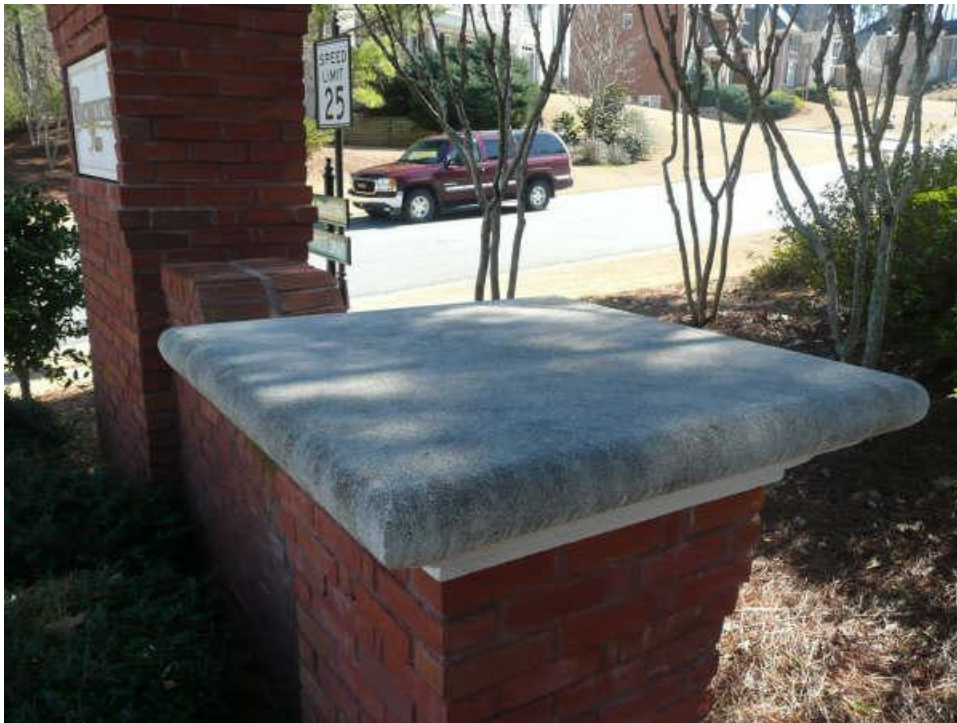
2. View of a typical synthetic stucco pilaster cap, showing dirty, stained and coarse appearance of the cap coating.

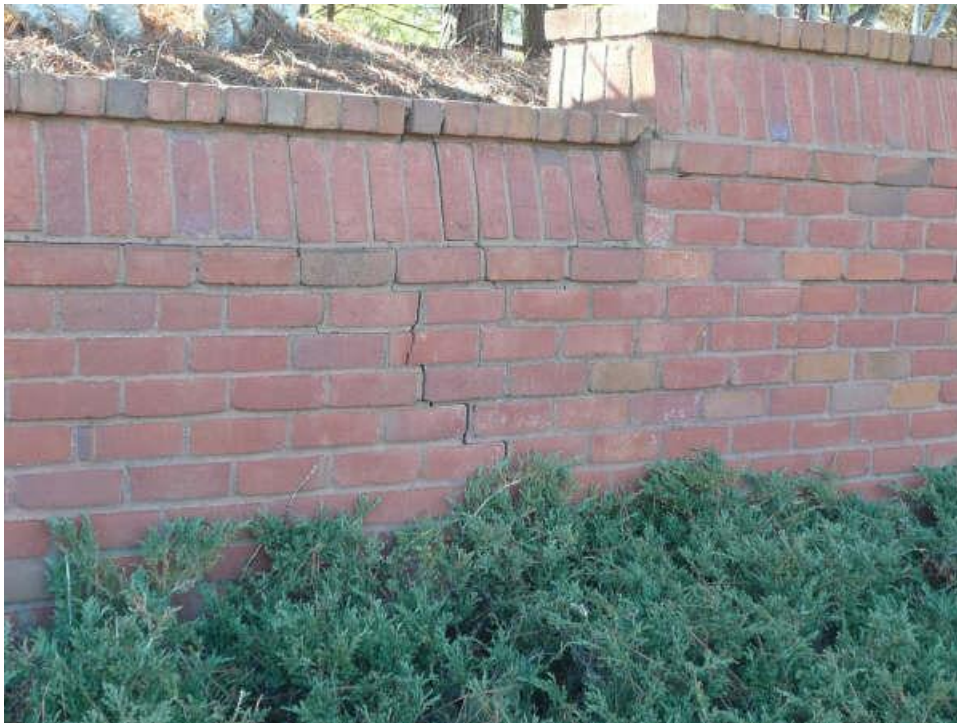
4. Another view showing step cracks and loose brick in the monument wall located along Grand Vista Approach.

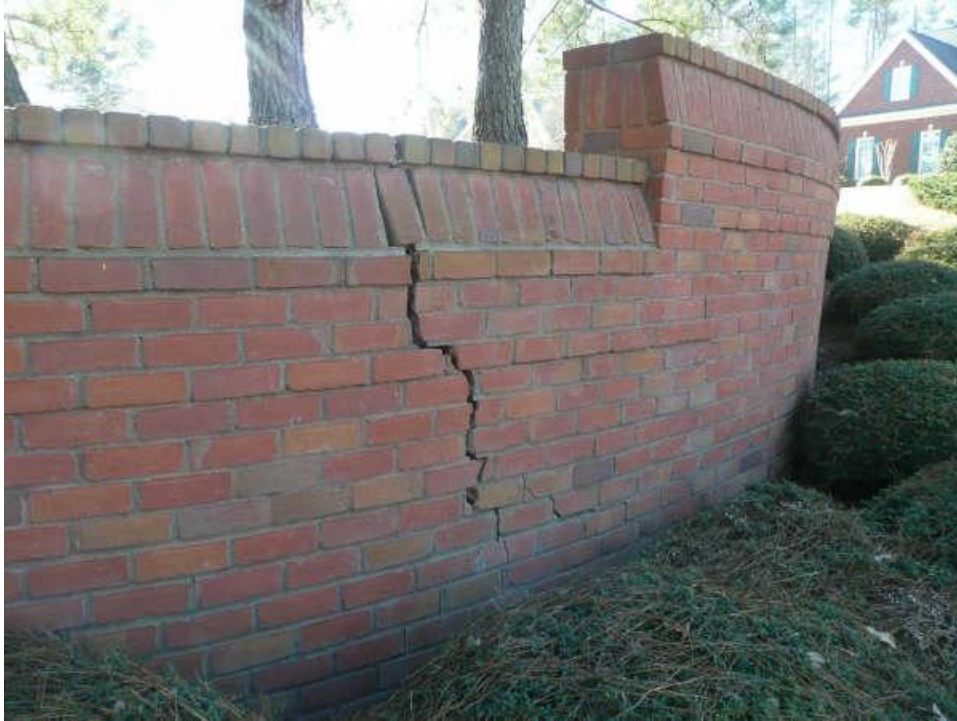
5. View showing the wide settlement crack and apparent outward movement at the west end of the monument along the south side of the Grand Vista Approach.

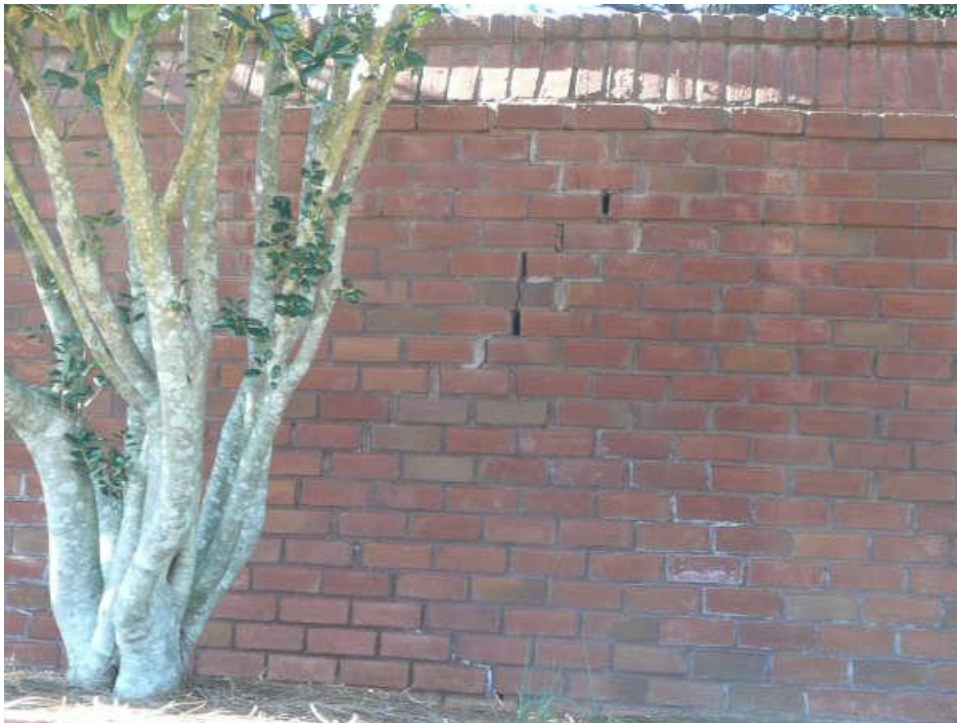
6. View showing a vertical crack in the upper level monument at the north side of Grand Vista Approach.

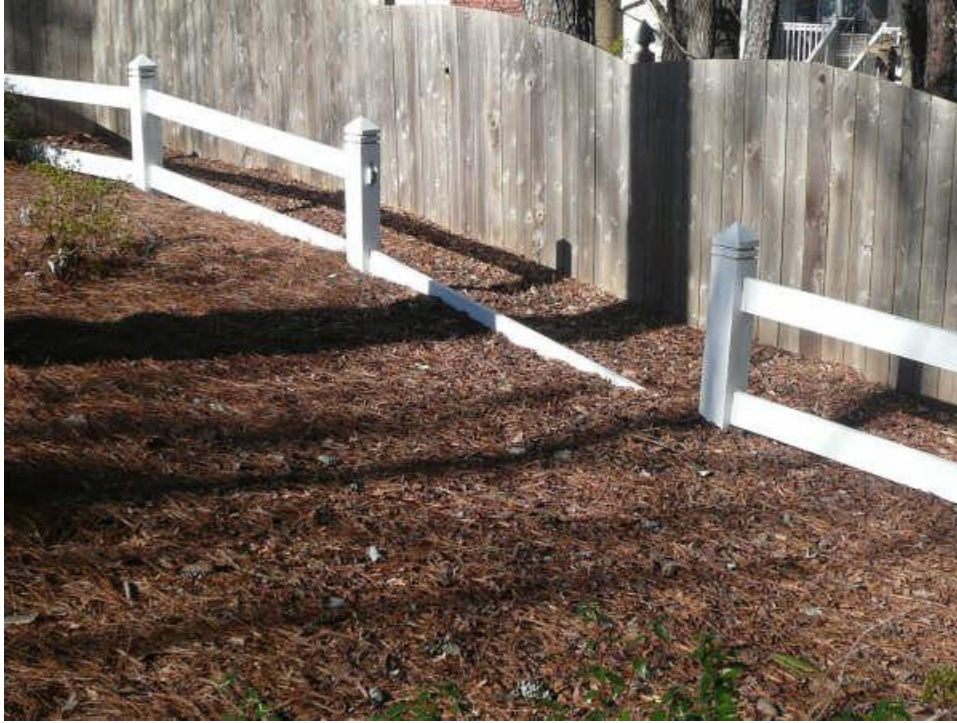
7. View showing missing and deteriorated fence boards along the north side of the Grand Vista Approach.

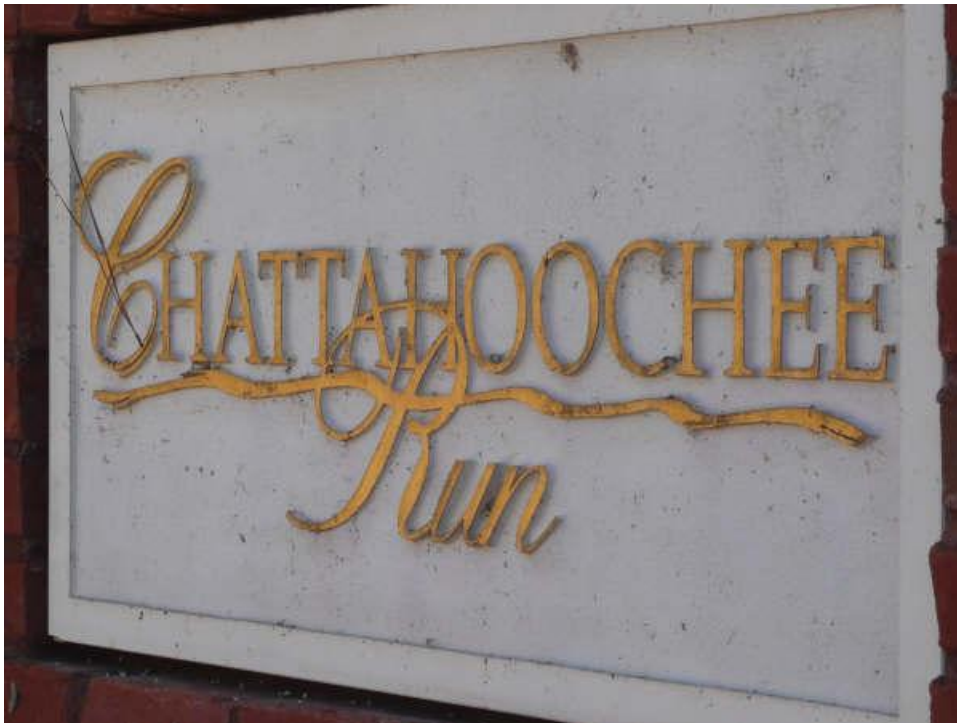
8. View showing the dirty and stained appearance of the logo sign at the McGinnis Ferry Road entrance.

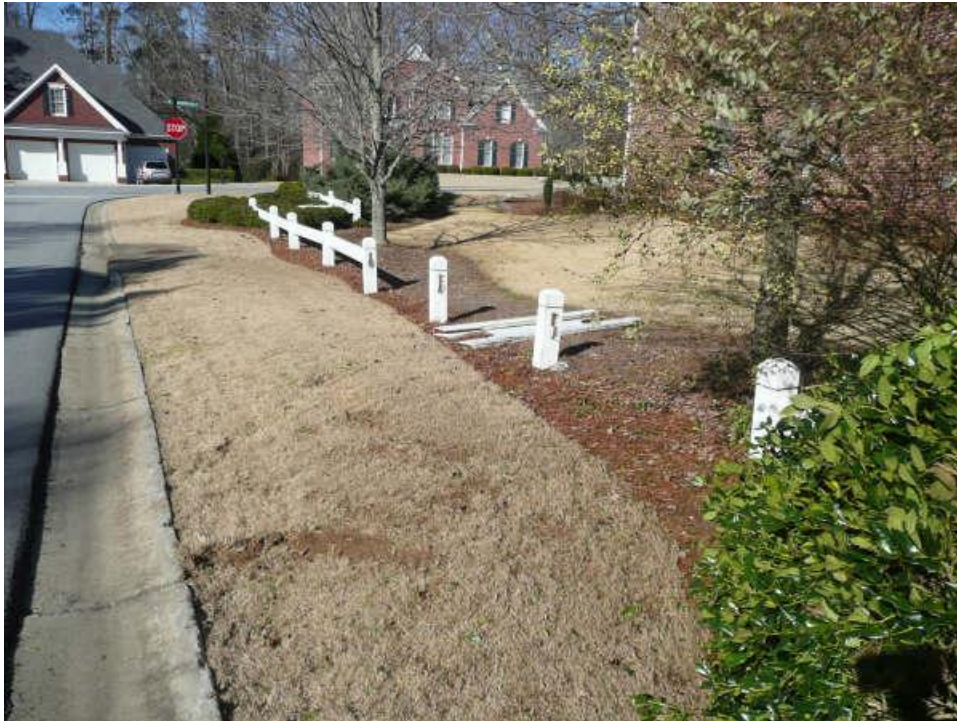
10. View showing missing and deteriorated fence boards at the entrance to the Riverside Community.

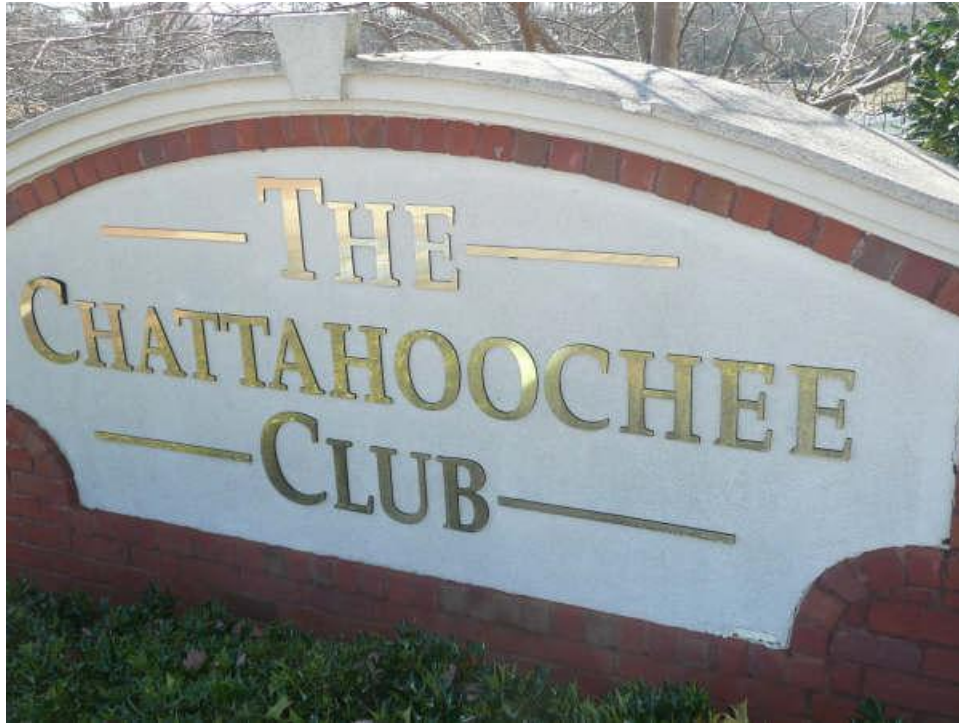
11. View of the monument sign at the clubhouse, showing the logo sign that is dirty, stained and damaged.

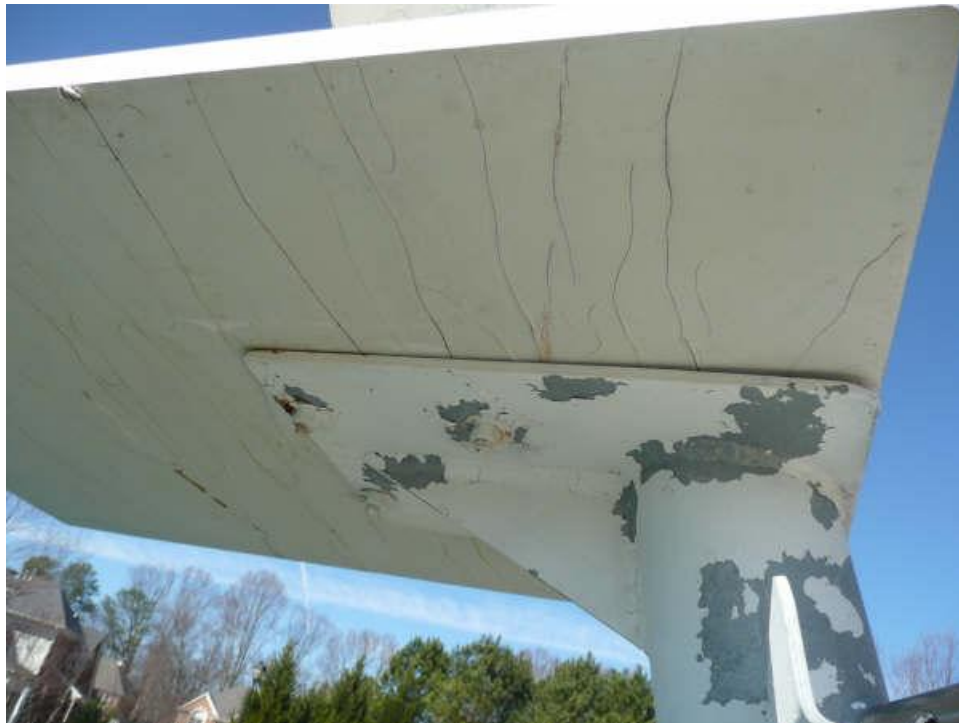
12. View showing the poor condition of the lifeguard platform at the competition pool.

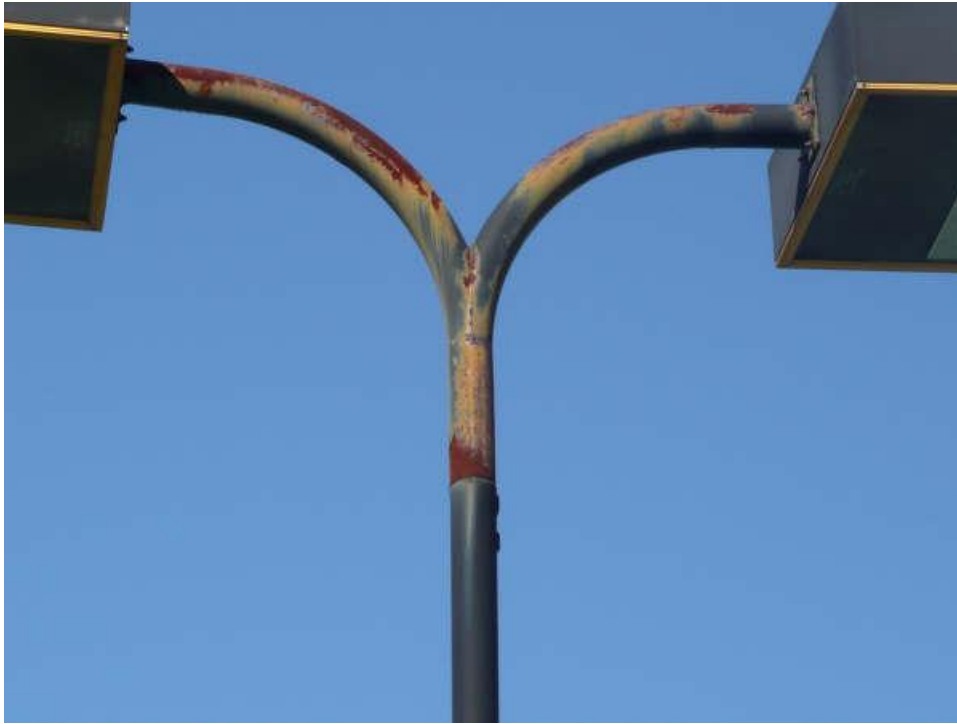
13. View of a typical tennis court light pole, showing the poor condition of the painted finish.

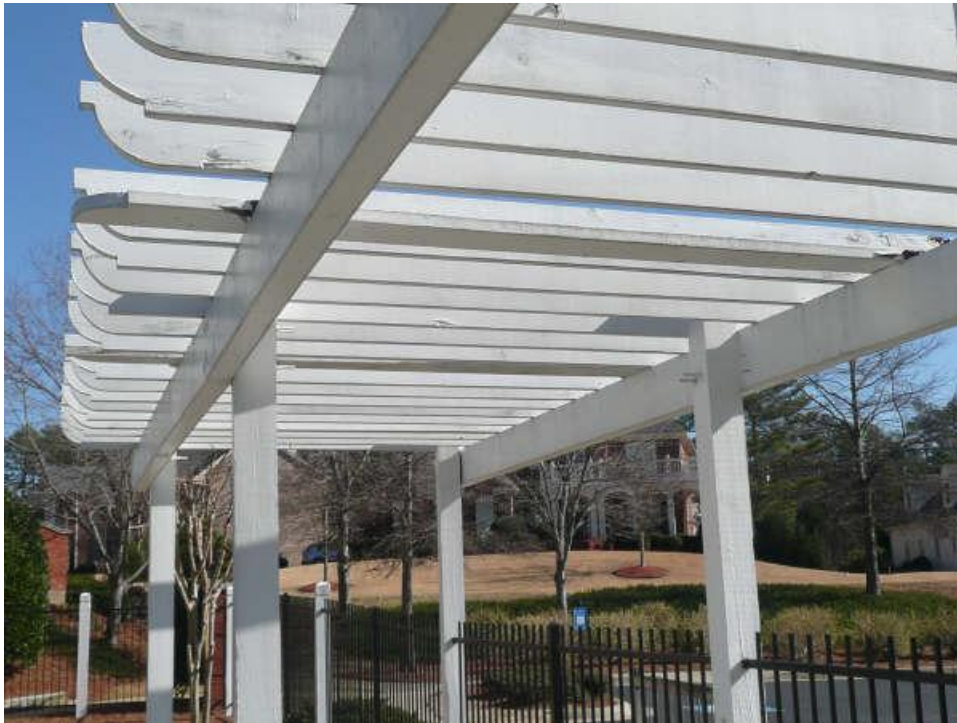
14. View of the arbor at the pool deck, showing several deteriorated members that have fallen over along the top of the arbor.

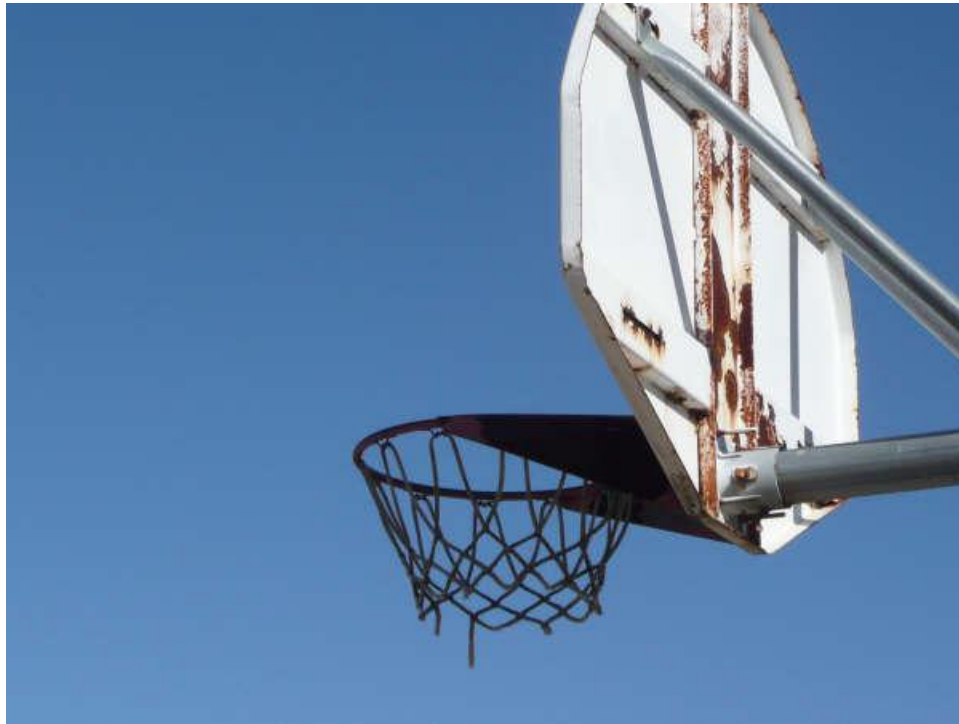
15. View of the basketball backboard, showing the extensive corrosion occurring at the back of the board.

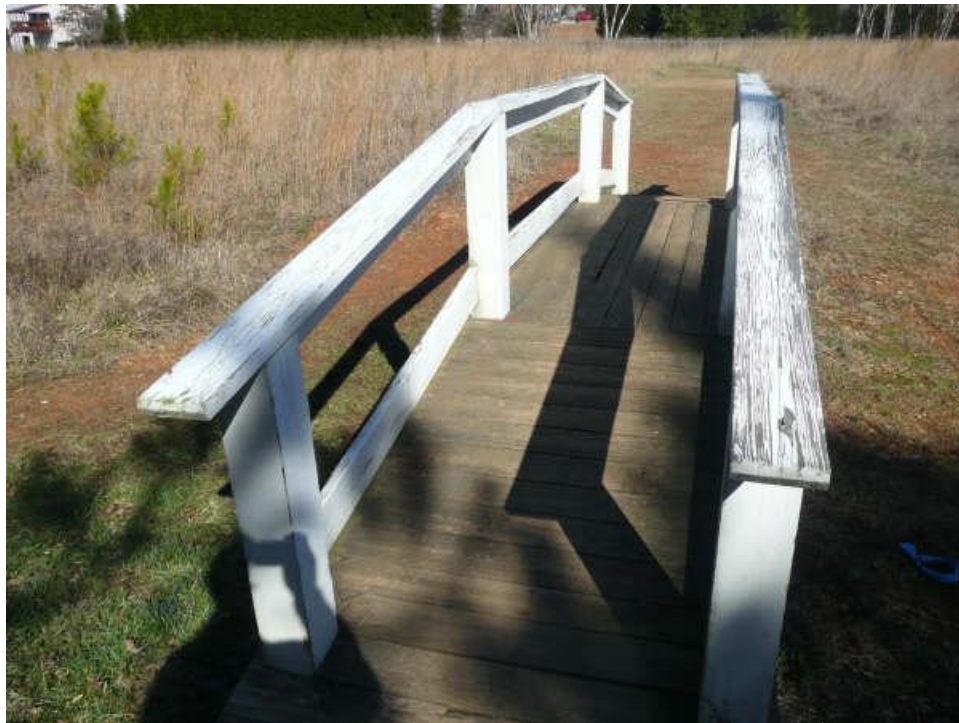
16. View of one of the pedestrian bridges in the athletic field, showing the poor condition of its painted finish.

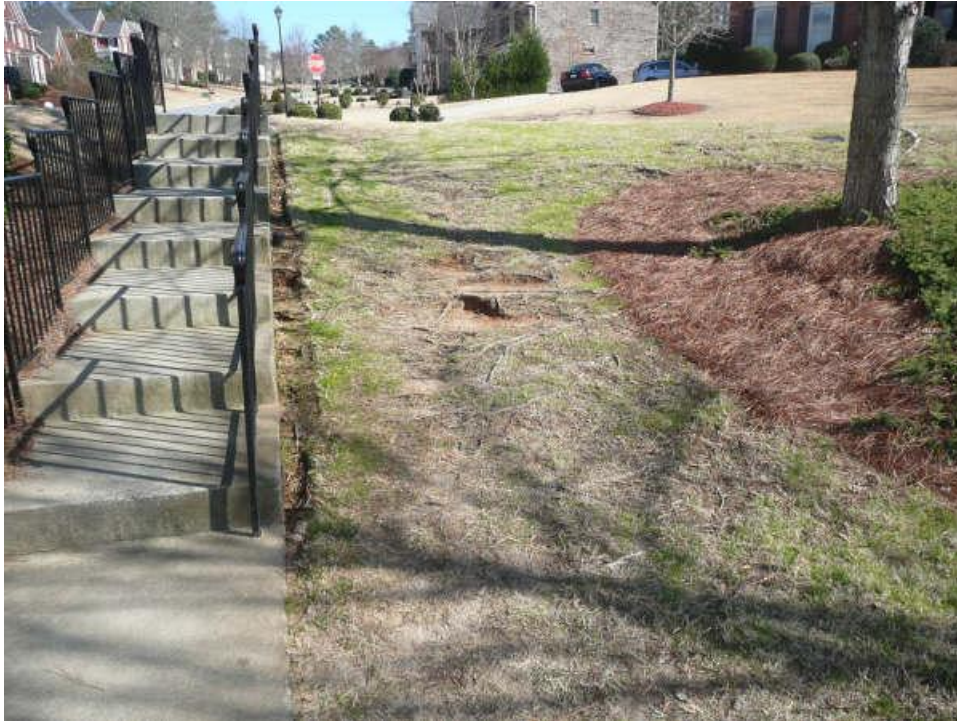
17. View of the steps at the left of the clubhouse showing erosion beginning to occur along the right side of the steps.

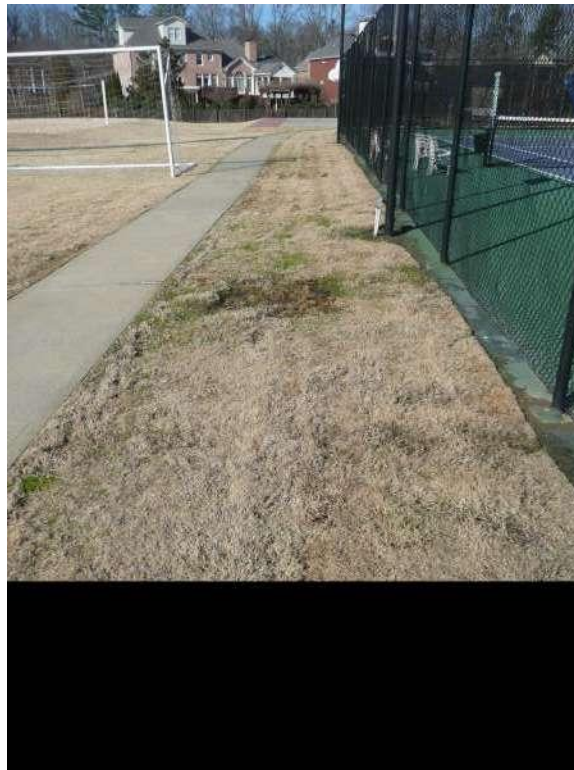
18. View showing evidence of poor drainage and ponding water at the rear of the tennis court.

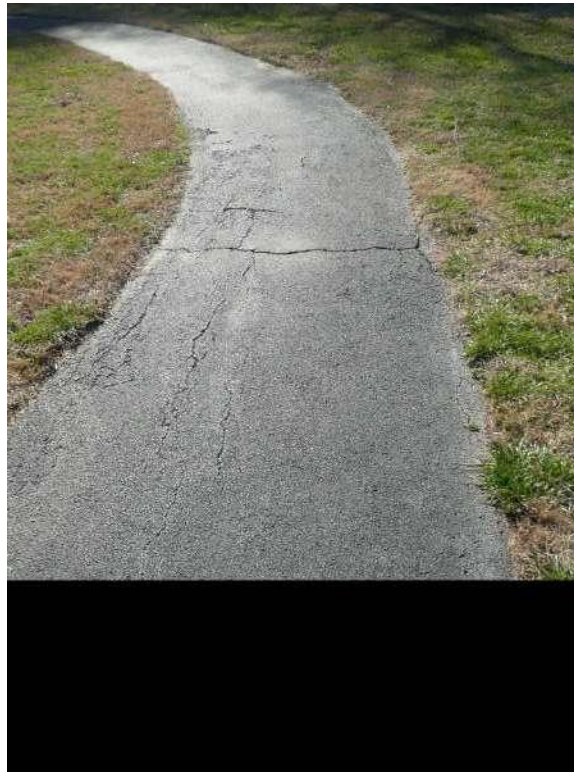
19. View showing cracks that have formed in the surface of the jogging path that should be sealed.

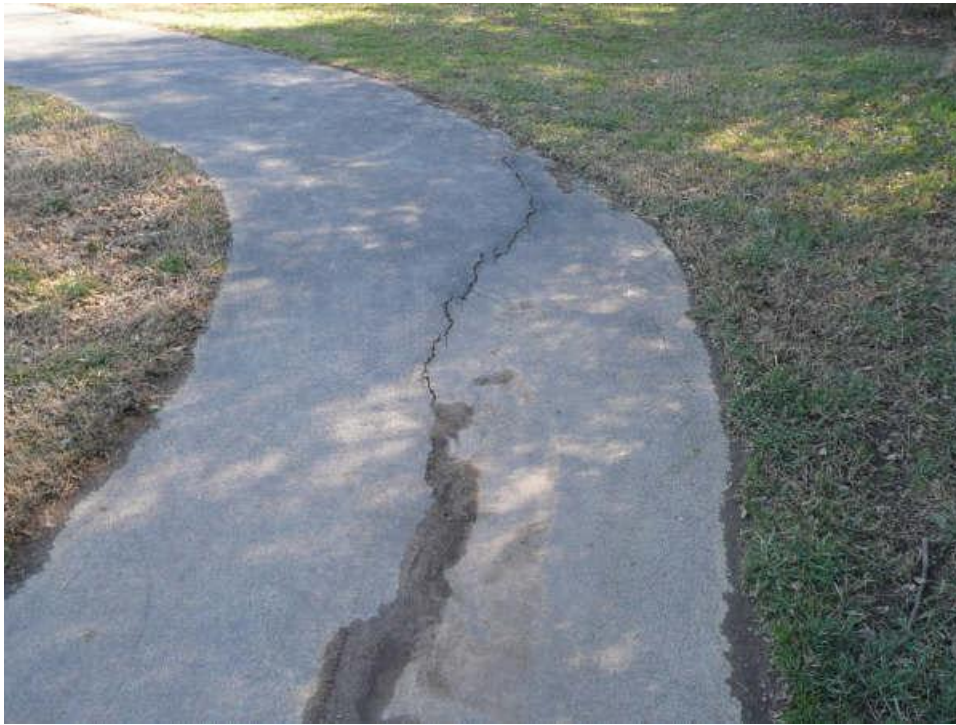
20. View showing cracking and slight settlement at a section of the jogging path.

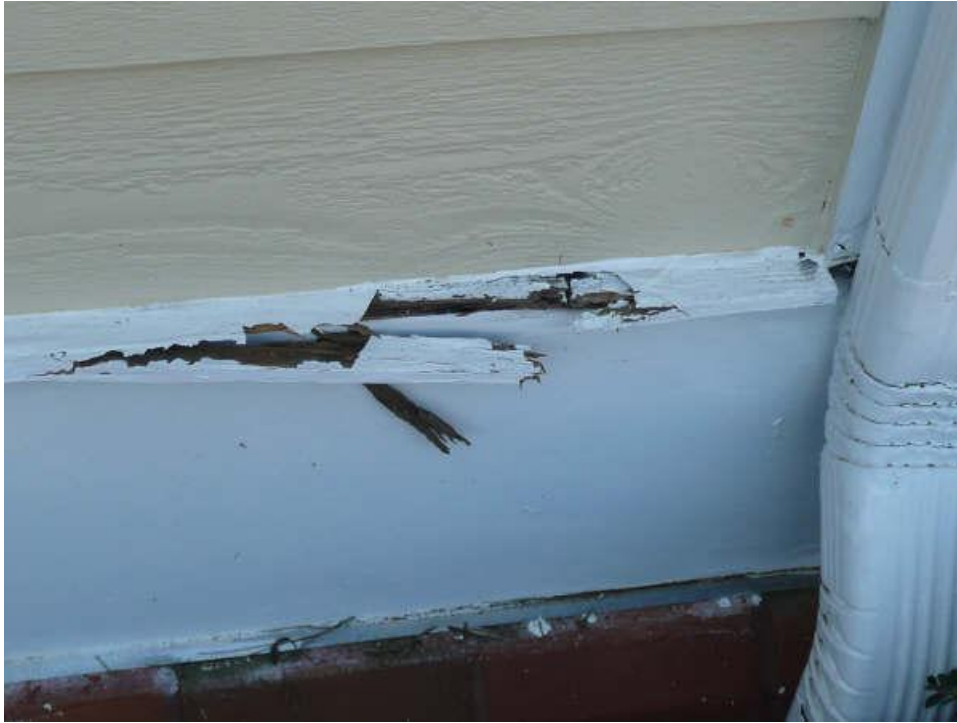
21. View showing deteriorated wood drip edge at the right front corner of the clubhouse.

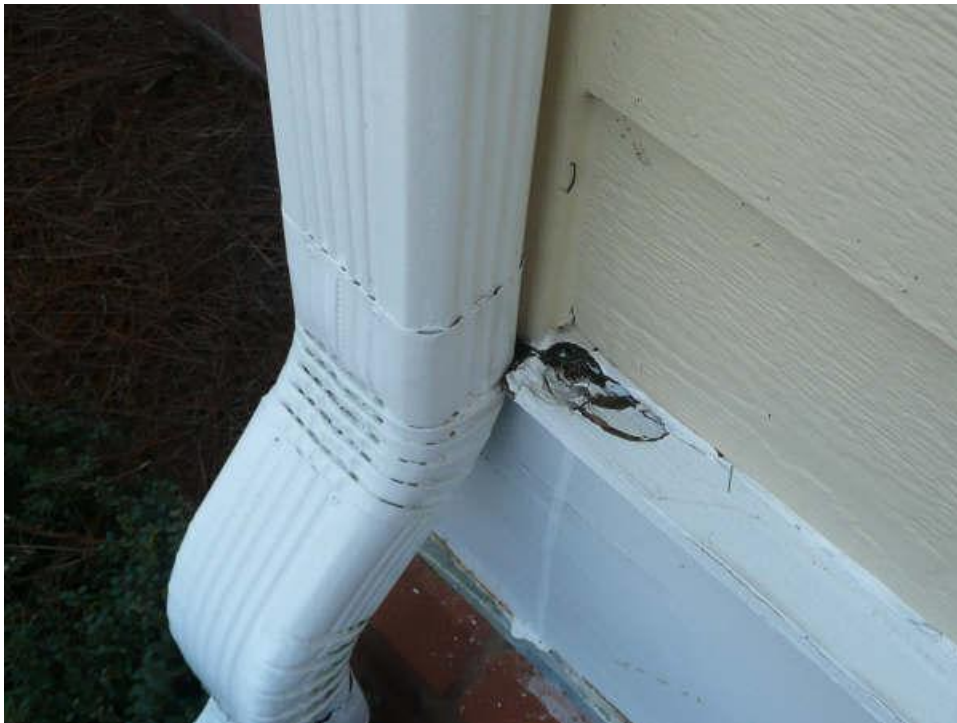
22. View showing deteriorated wood drip edge at the left front corner of the clubhouse.

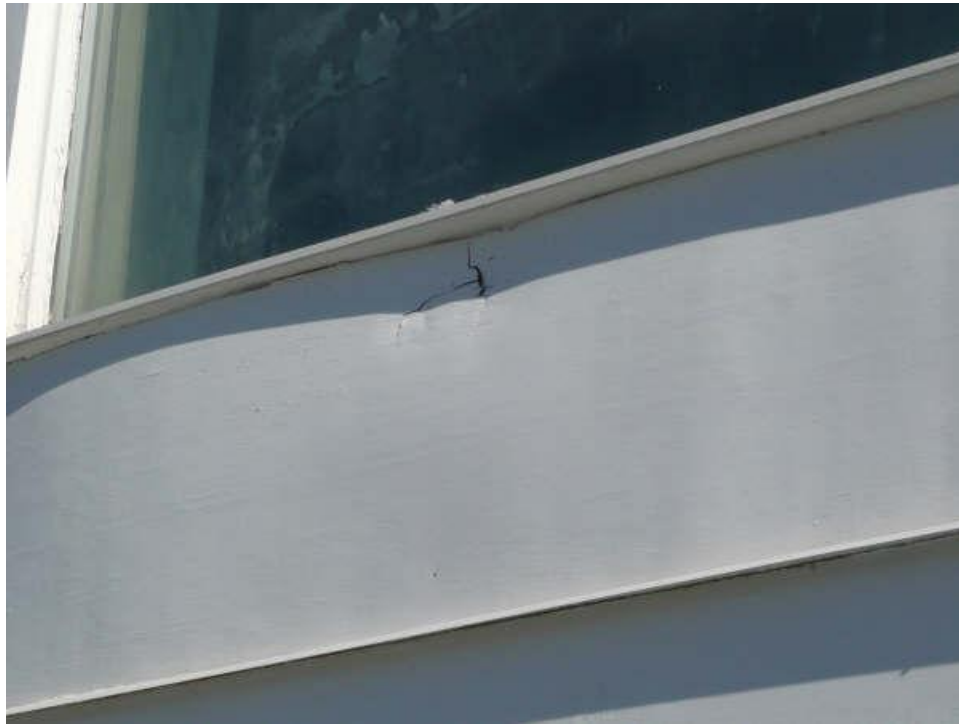
23. View showing deteriorated wood trim below the arched window at the rear of the clubhouse.

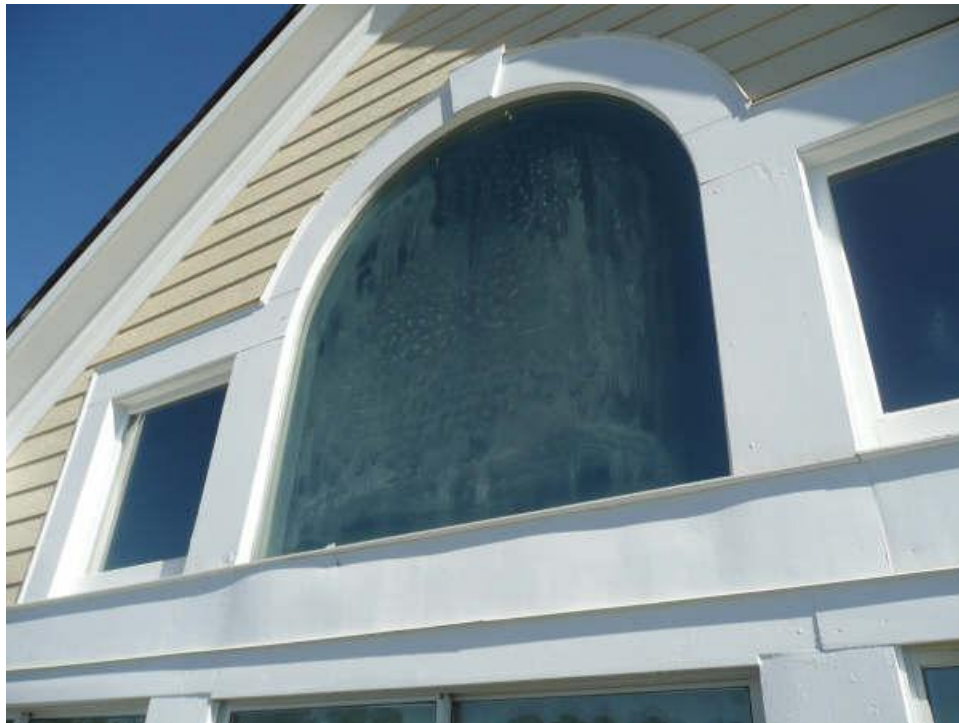
24. View of the arched glass window at the rear of the clubhouse whose glazing seal has failed.

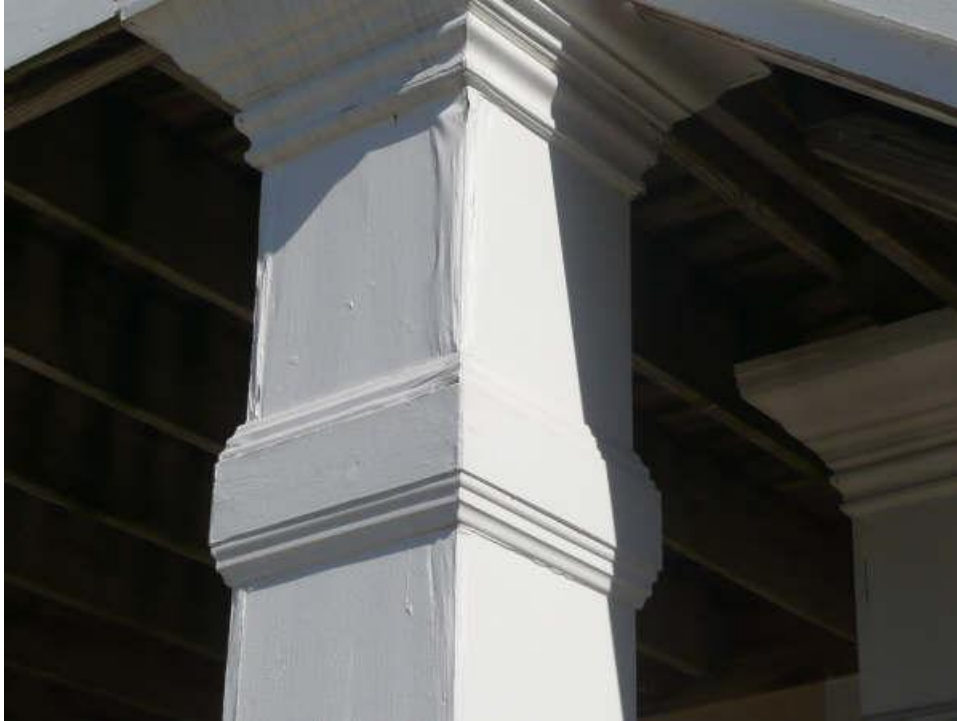
25. View showing blistered paint at one of the rear deck column surrounds that is an indication of possible wood rot.

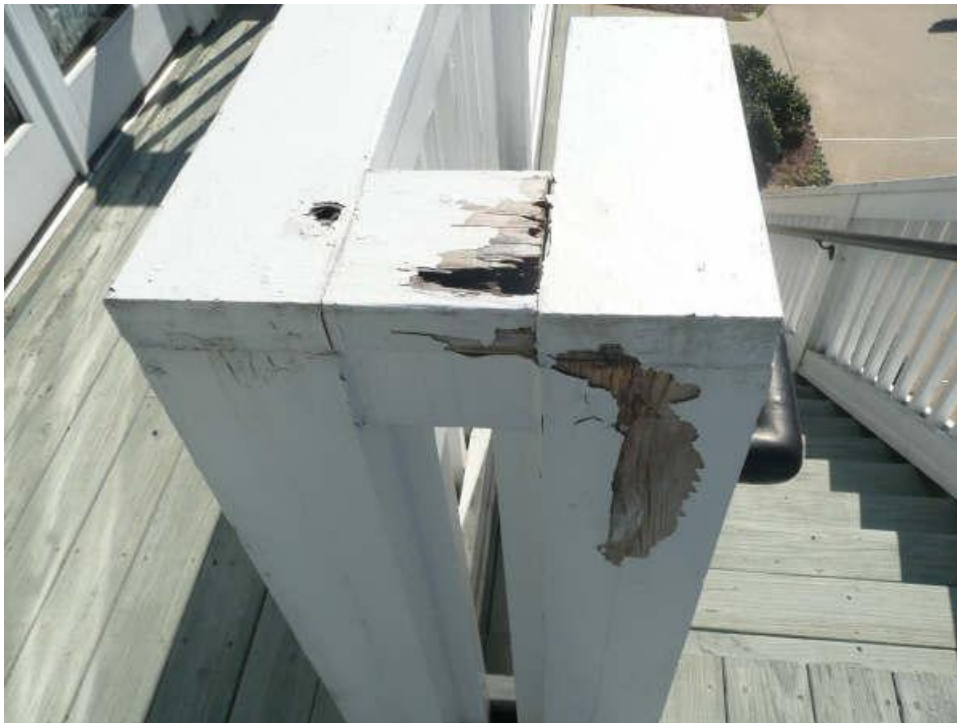
26. Deteriorated wood rail cap and post at the top of the stairs at the clubhouse deck.

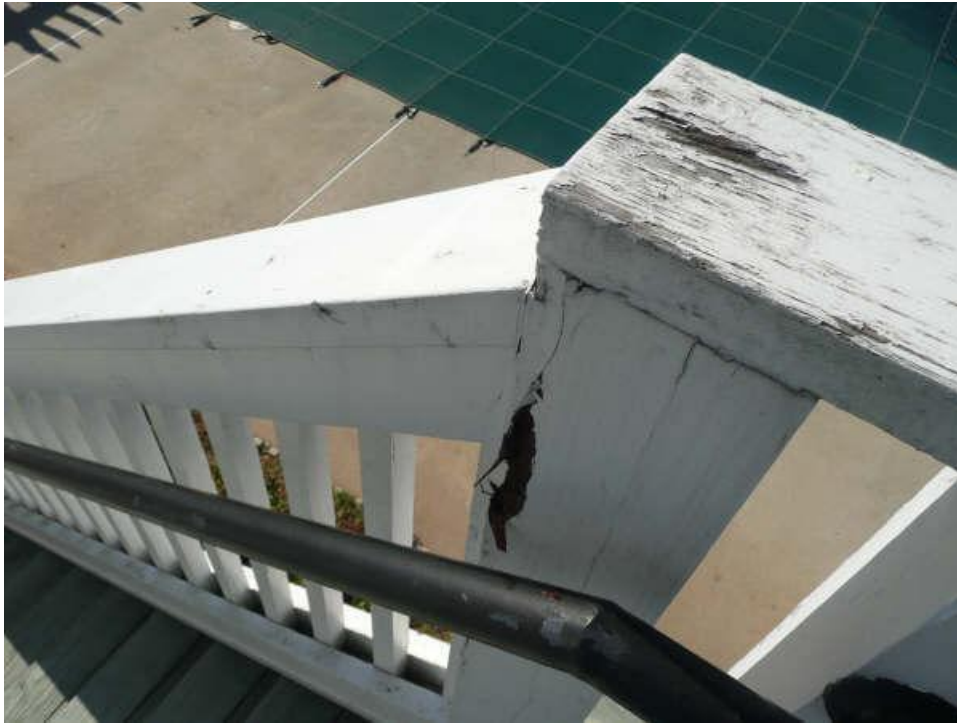
27. Deteriorated wood rail cap and post at the opposite side of the stairs at the clubhouse deck.

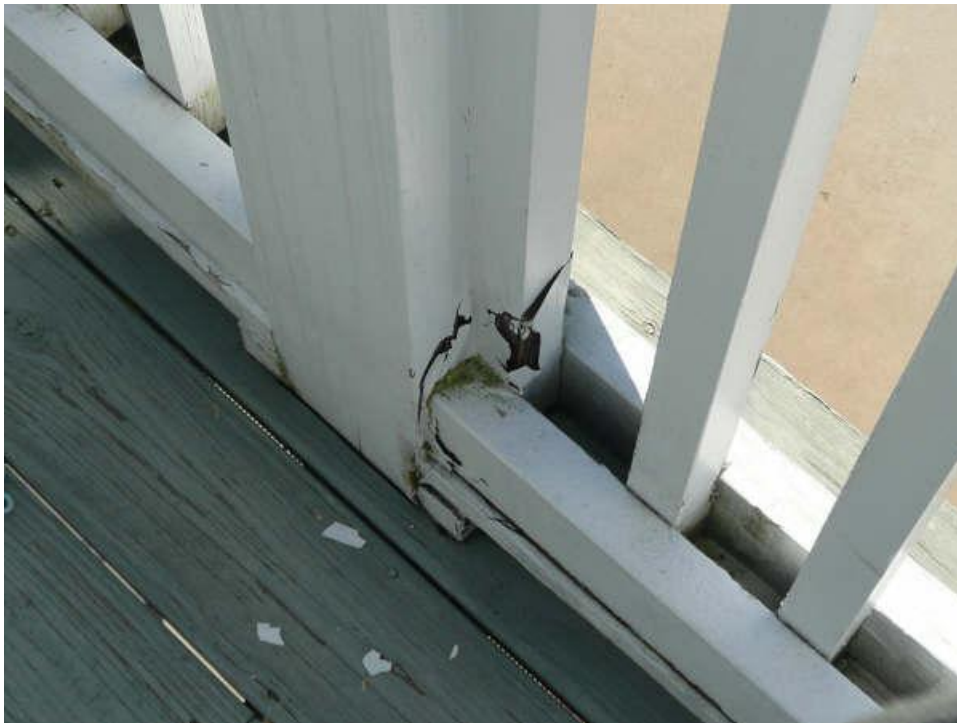
28. Deteriorated wood rail, post and picket at the bottom of the railing at the clubhouse deck.

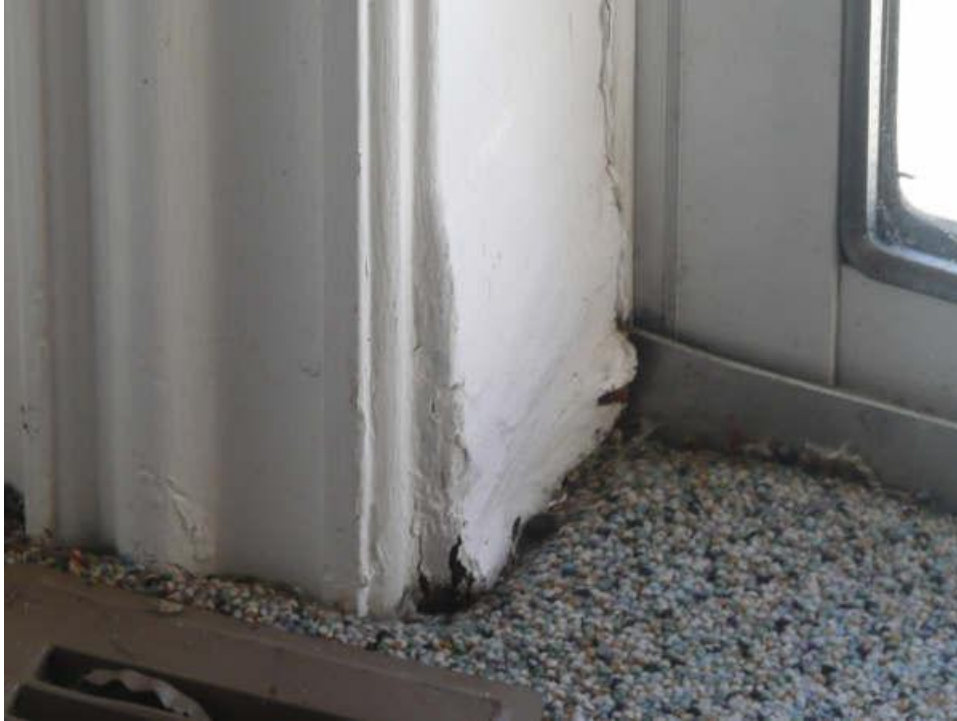
29. View showing deteriorated wood base, which is typical at most of the sliding glass door openings at the first floor of the clubhouse.

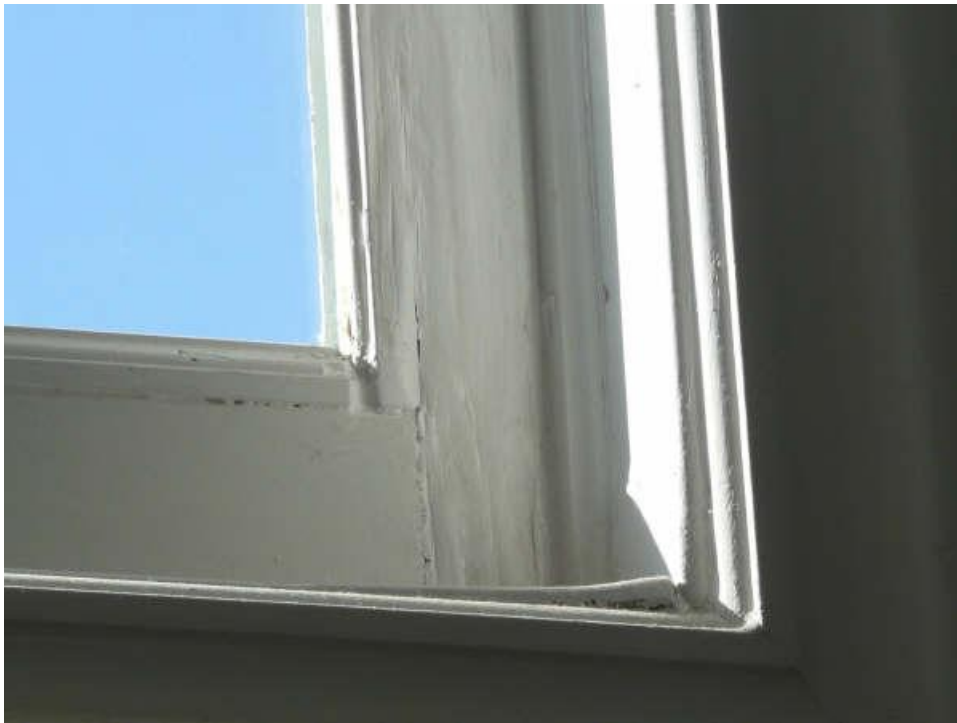
30. View showing deteriorated wood trim at the bottom of the windows above the sliding glass doors.

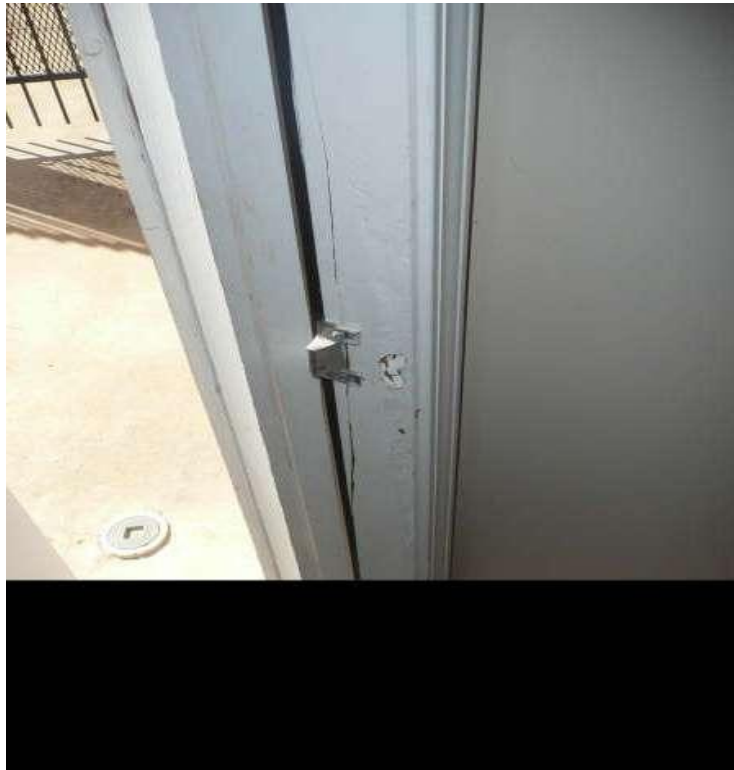
31. View showing the door frame at the basement level of the clubhouse, showing evidence of deterioration due to termite infestation.
